Monitoring Data Record

Project Title: B-3157 (Michael's Branch Site) COE Action ID: 200020843

Stream Name: Michael's Branch

Date Construction Completed: 9/5/07 Monitoring Year: (3) of 5

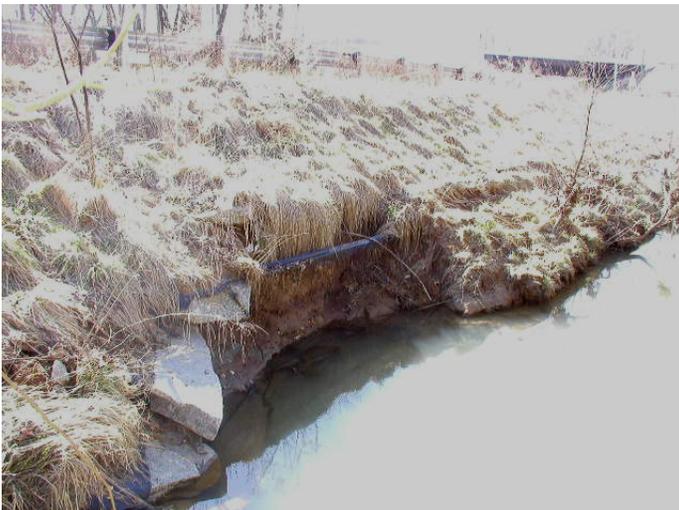
Date 3/1/10	STA. 15+30 -Y2- (Additional Photo)	STA. 5+90 -Ramp C- (Additional Photo)	Station Number	Station Number	Station Number
Structure Type	Crossvane	Crossvane			
Is water piping through or around structure?					
Head cut or down cut present?					
Bank or scour erosion present?	Erosion on left bank at the end of crossvane arm	Erosion on right bank behind right crossvane arm			
Other problems noted?

STA. 15+30 -Y2 - Erosion on left bank

Michael's Branch is stabilized for the Year 3 Winter evaluation, except for, the areas noted below. NCDOT plans to live stake these eroded areas to help stabilize the streambanks. A bankfull event had occurred onsite since the last monitoring evaluation. NCDOT will continue to monitor Michael's Branch.

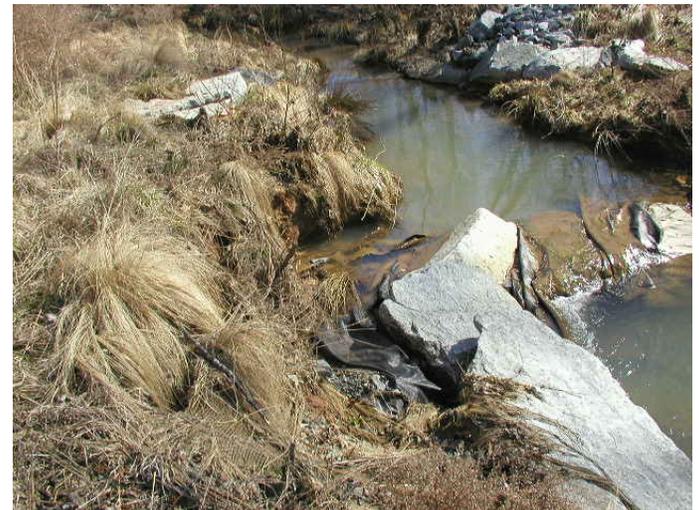
STA. 5+90 -Ramp C-Erosion behind right arm of crossvane
